# Consultant Vegetation Management Recommendations

## Stormwater Utility Vegetation Plan

# Vegetation Management for Stormwater Properties Report

## **Sister Oak Ponds**

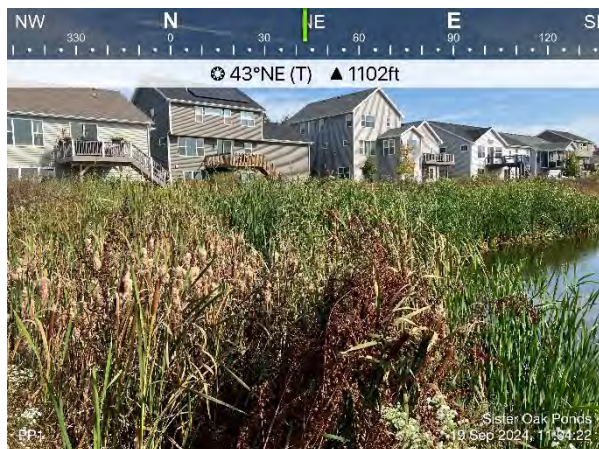
**Photo #3** Photo point 1, view northeast of wetland vegetation, primarily cattail, along wet pond perimeter

The perimeter of the wet pond is vegetated by wetland plants characteristic of wet meadow and shallow marsh communities (Table C-2, Appendix C). Invasive hybrid cattail (*Typha x glauca*) was one of the dominant species observed and is present in scattered patches along the water's edge. The open water portion of the pond was primarily clear except for some scattered duckweed (*Lemna minor*) and unidentified floating-leaf pondweeds (*Potamogeton* sp.) with some algae at the eastern end. Willows (*Salix* spp.) had recently been removed around the wet pond, evidenced by cut stumps and woody debris piles. A minor amount of sediment build-up was observed at the culvert outfalls into the pond. Scattered trash, primarily plastic water bottles, was observed.

It is recommended that cattail is controlled within the wet pond. Cattail is currently creating dense clusters around the perimeter of the pond and will likely continue to spread around the pond margin if left unchecked. Cattail stands can take over shallow marsh wetlands, drainage swales, and pond perimeters; thereby outcompeting other useful native emergent plants that are important to diverse wetland communities (EPA 2009). Diverse plant communities support diverse and balanced aquatic communities that host beneficial species such as mosquito predators (EPA 2009).

Efforts to mechanically cut the cattail stands and then remove the cut biomass or reduce the biomass with prescribed burning should be conducted first. During the following growing season, cattail should be treated with herbicide to kill the plants. Herbicide application with a wick, such as a wand attachment to a backpack sprayer, is recommended to reduce herbicide damage to desirable species.

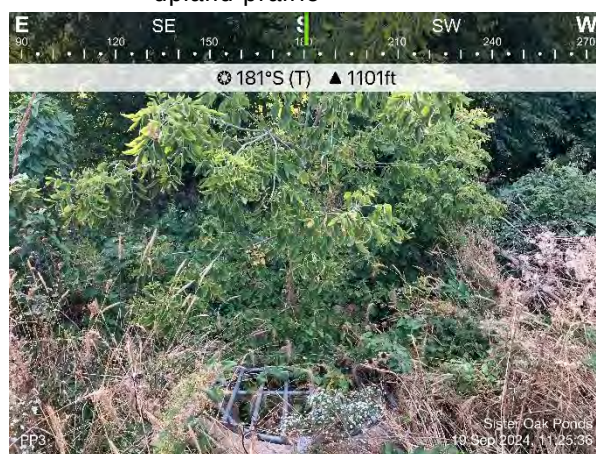
Tree saplings are growing into the riprap at the culvert outfall in the southwestern portion of the infiltration basin as well as within riprap placed along the southern slope (see photos #6-8, Appendix C). It was hard to assess the functionality of the riprap along the southern perimeter of the infiltration basin due to the vegetative cover. A large portion of a black cherry tree has fallen onto the southern berm of the infiltration basin and is covering the ground surface (see photo #9, Appendix C).

**Photo #6** Photo point 3, culvert with box elder trees in riprap on the southwest side of the infiltration basin.

Recent willow removal had been conducted by the City around the perimeter of the wet pond. Woody tree saplings, shrubs, vines, and brambles were observed along the southern berm, exterior slope, riprap, and culvert outfall of the infiltration basin. This woody encroachment will shade out desired herbaceous vegetation, reduce native species diversity, and may destabilize the constructed basins. Trees and brush with extensive woody root systems can destabilize dams, embankments, and side slopes by creating seepage routes (EPA 2029) and can cause blockages within conveyance structures.

It is recommended that encroaching woody vegetation be cut and removed from the Site or placed in small piles along the tree line. Herbicide should be applied to the cut stems to minimize resprouting. As feasible, invasive shrubs and weeds within the southern tree line should be controlled to reduce spread into the native plant communities. The downed black cherry tree that has fallen onto the basin berm should be cut and removed from Site. Removal of encroaching woody vegetation is recommended to be a continued management task at the Site. Prescribed burning should be used as a management tool

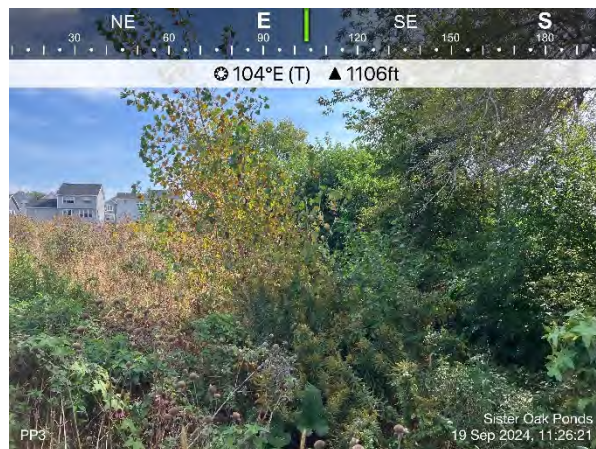
**Photo #8** Photo point 3, view east along the southern perimeter of the infiltration basin with woody encroachment

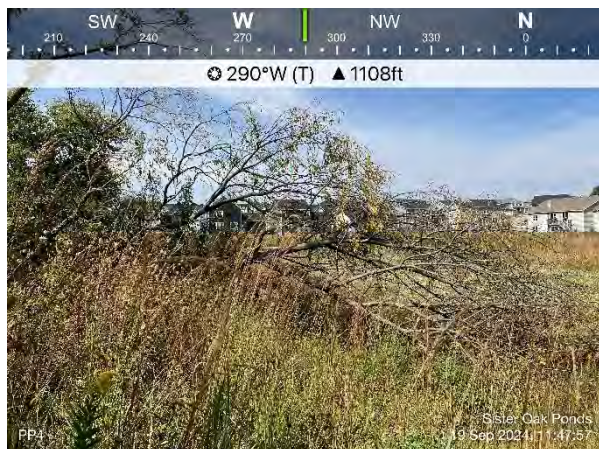
**Photo #9** Photo point 4, view west along the southern berm of the infiltration basin with a downed tree

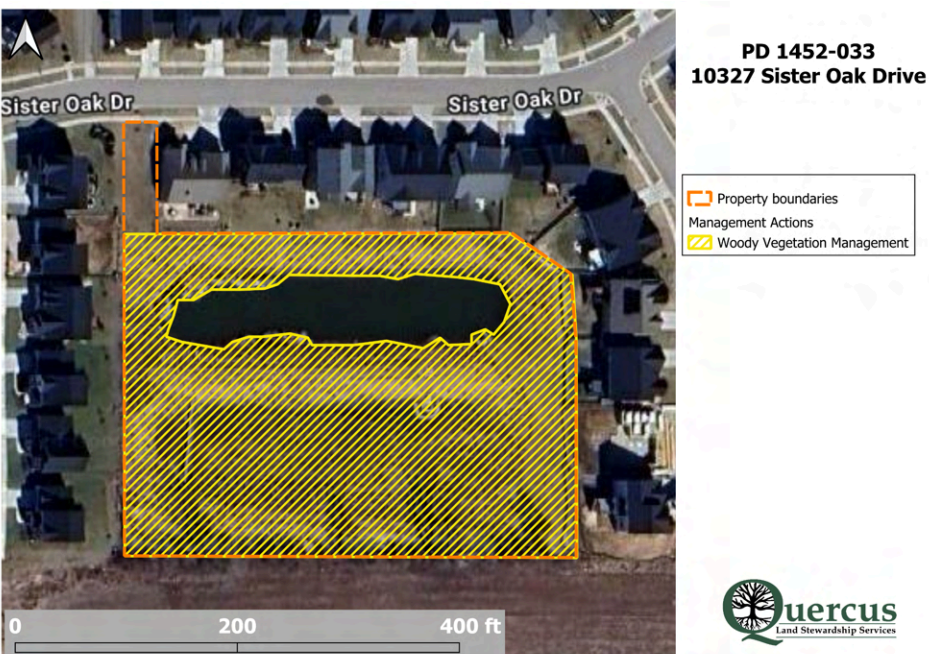
Figure 3

PD 1452-003 Woody Vegetation Management Area . Depicted above is the boundary of the proposed woody vegetation management area..

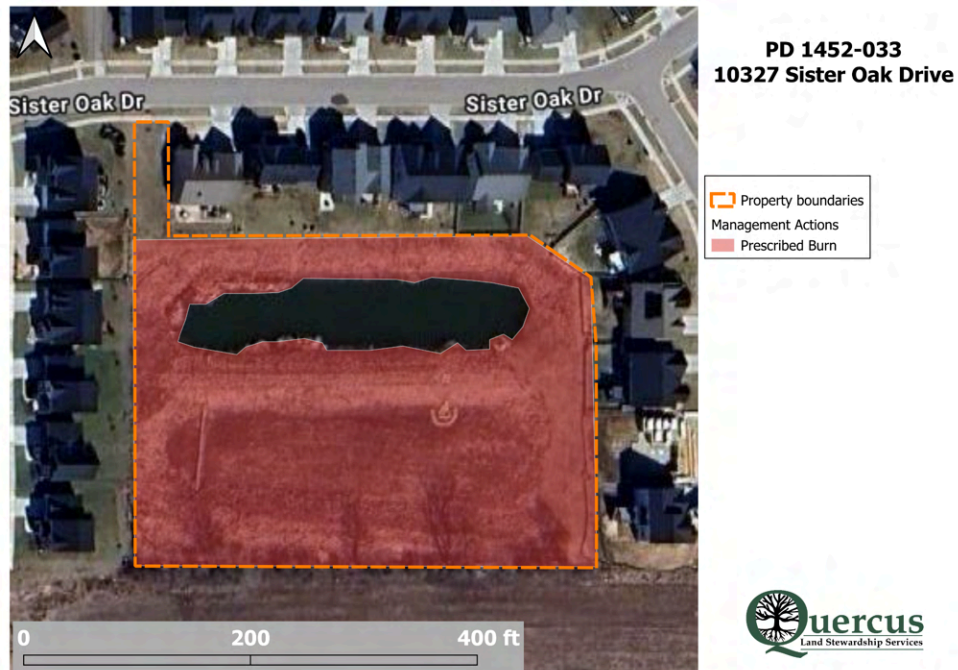
Figure 4

PD 1452-003 Prescribed Burn Area . Depicted above is the boundary of the proposed prescribed burn management area..

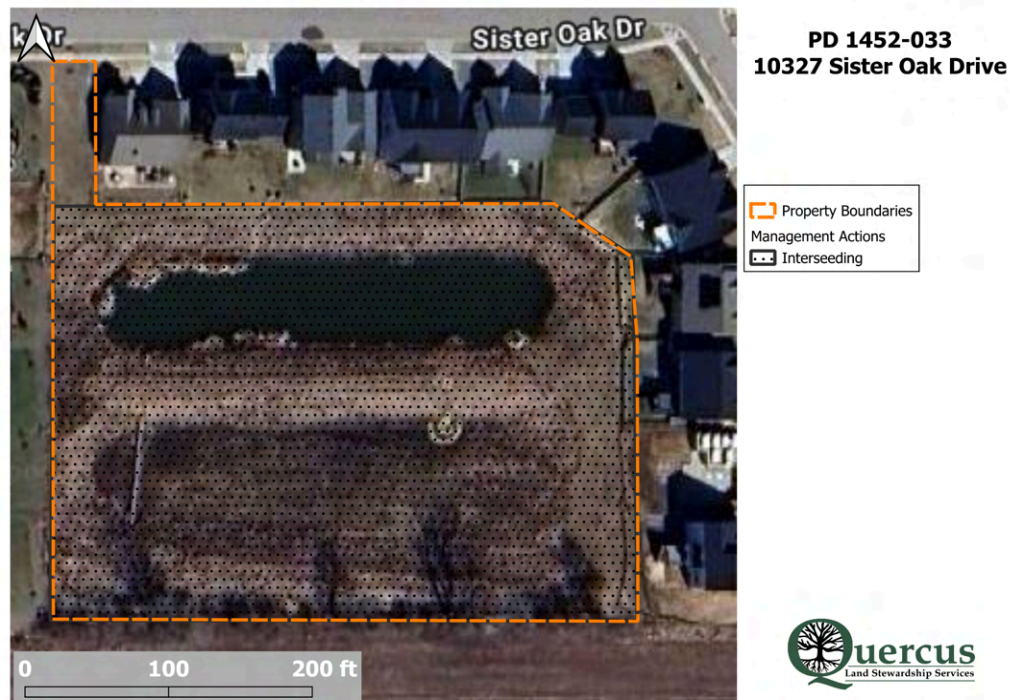
Figure 5

PD 1452-003 Interseeding Management Area . Depicted above is the boundary of the proposed interseeding management area..

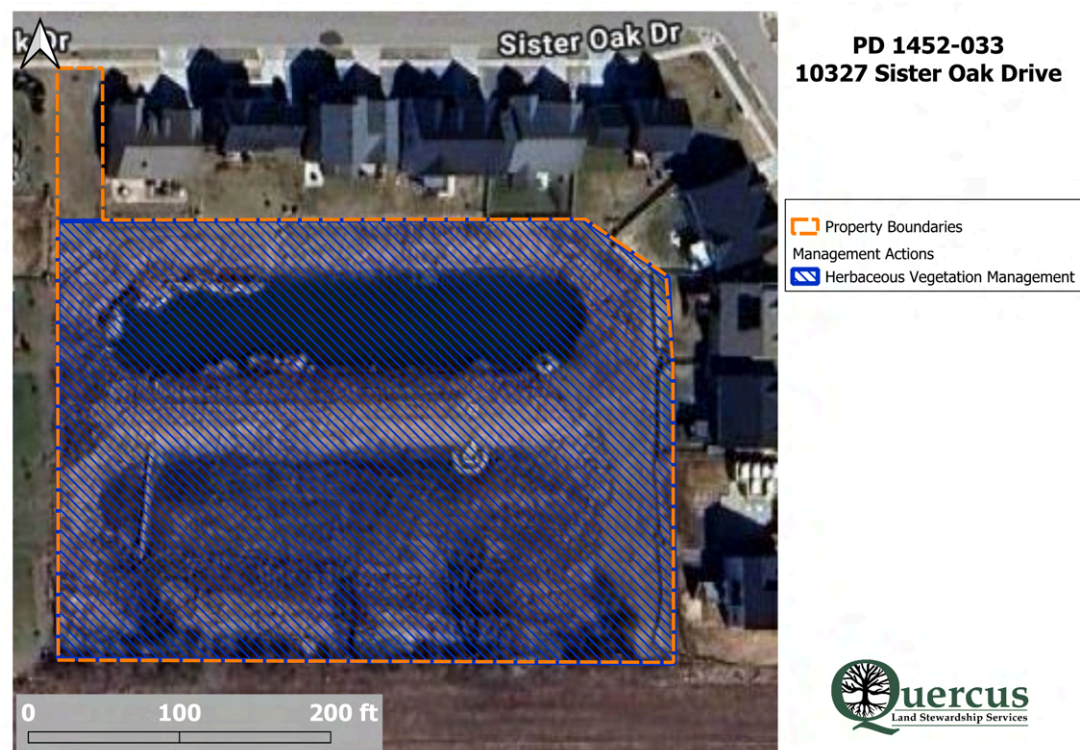
Figure 6

PD 1452-003 Herbaceous Vegetation Management Area . Depicted above is the boundary of the proposed herbaceous vegetation management area..

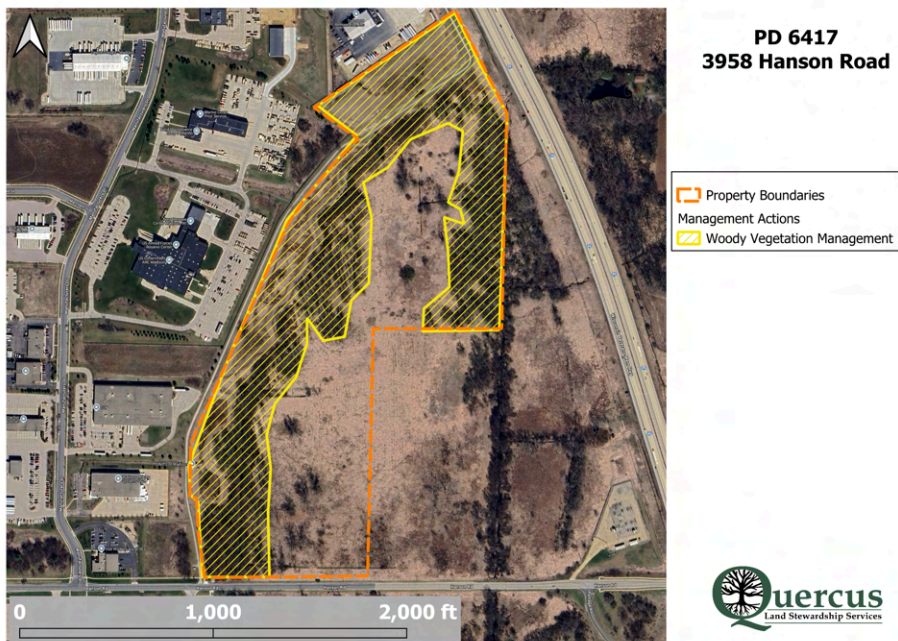
Figure 9

PD 6417 Woody Vegetation Management Area . Depicted above is the boundary of the proposed woody vegetation management area..

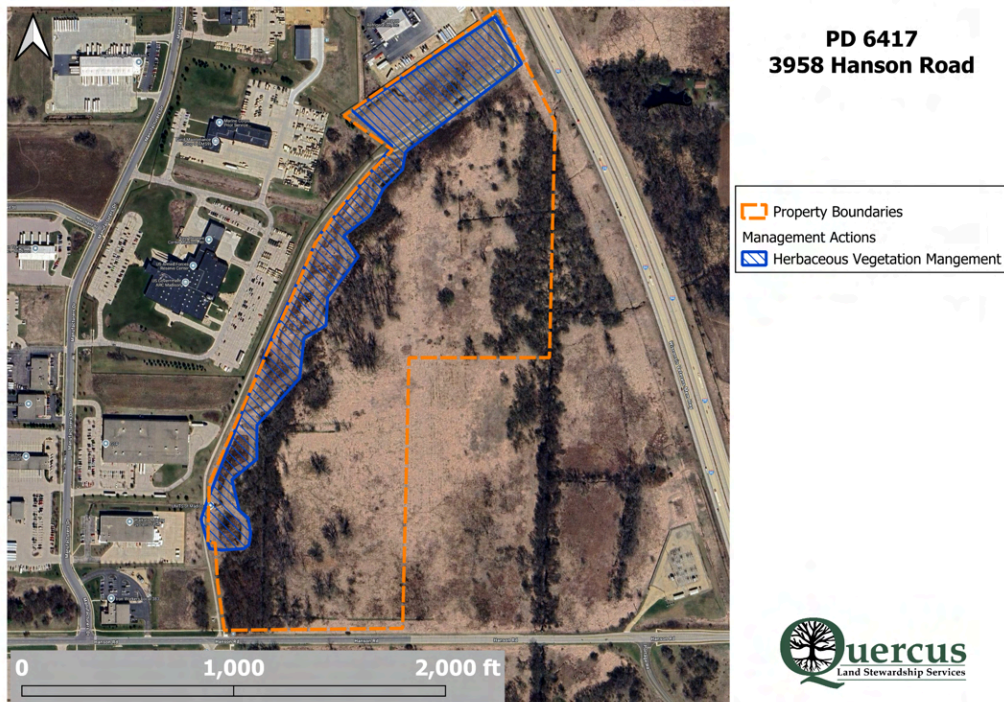
Figure 10

PD 6417 Herbaceous Vegetation Management Area . Depicted above is the boundary of the proposed herbaceous vegetation management area.

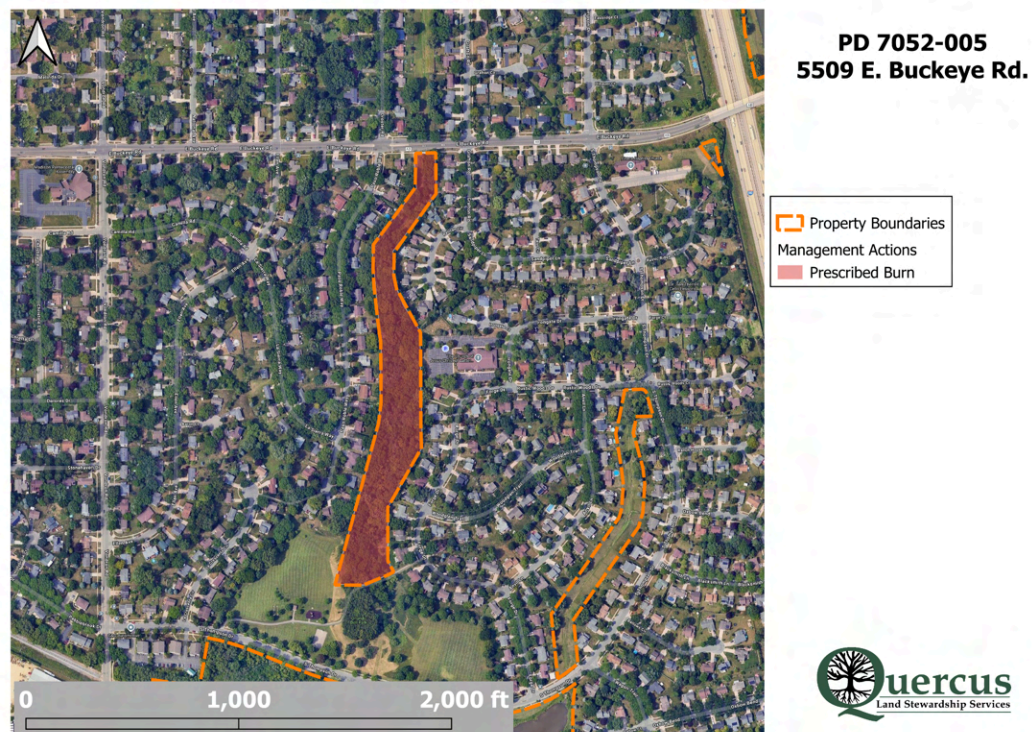
Figure 13

PD 7052-003 Prescribed Burn Management Area . Depicted above is the boundary of the proposed prescribed burn management area..Due to QGIS constraints the creek has not been delineated out.

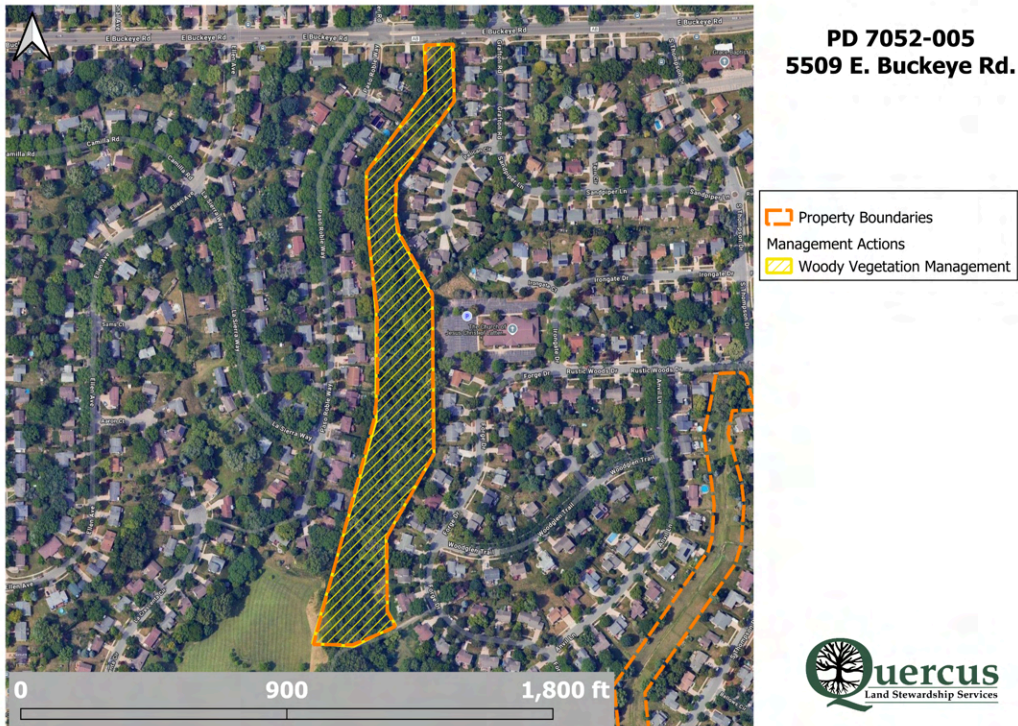
Figure 14

PD 7052-005 Woody Vegetation Management Area.. Depicted above is the boundary of the proposed woody vegetation management area..Due to QGIS constraints the creek has not been delineated out.

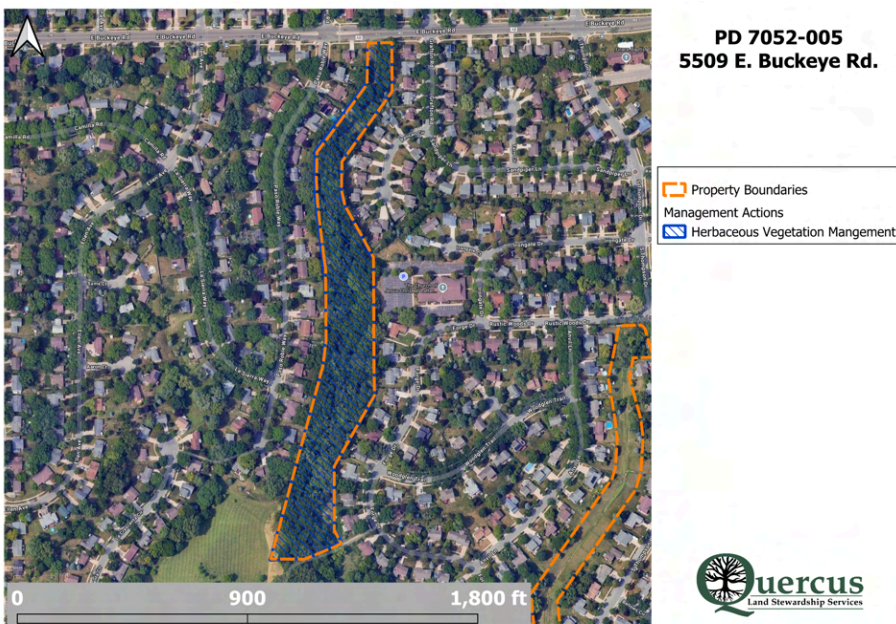
Figure 15

PD 7052-005 Herbaceous Vegetation Management Area.. Depicted above is the boundaries of the proposed herbaceous vegetation management area..Due to QGIS constraints the creek has not been delineated out.

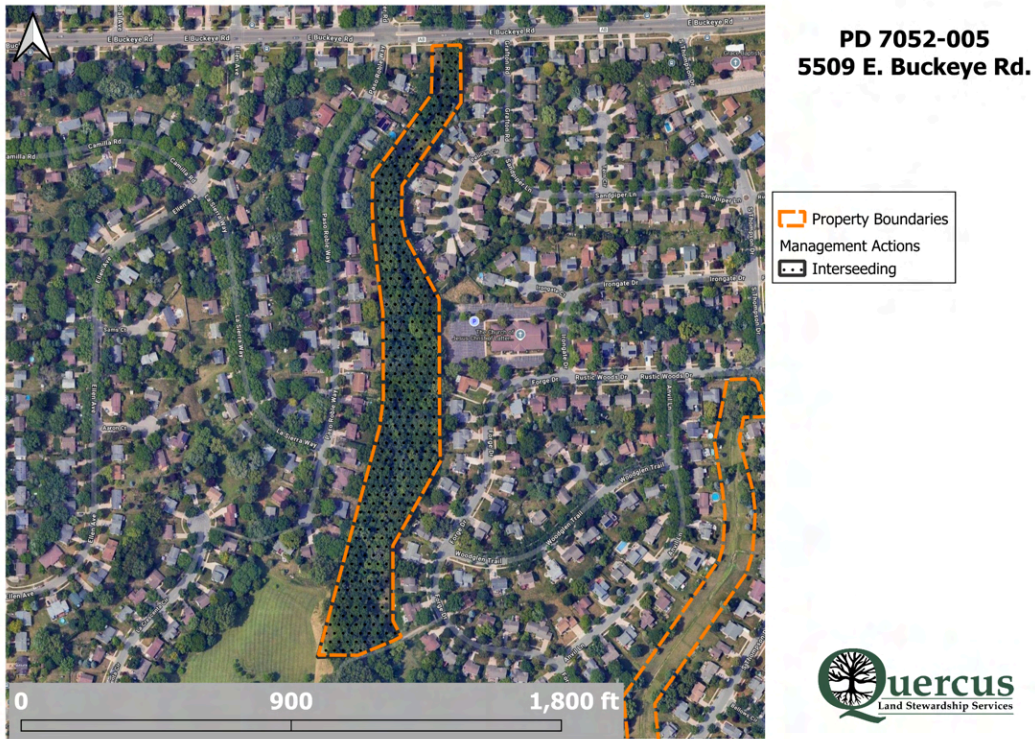
Figure 16

PD 7052-005 Interseeding Areas. Depicted above is the boundary of the proposed interseeding area. Due to QGIS constraints the creek has not been delineated out.

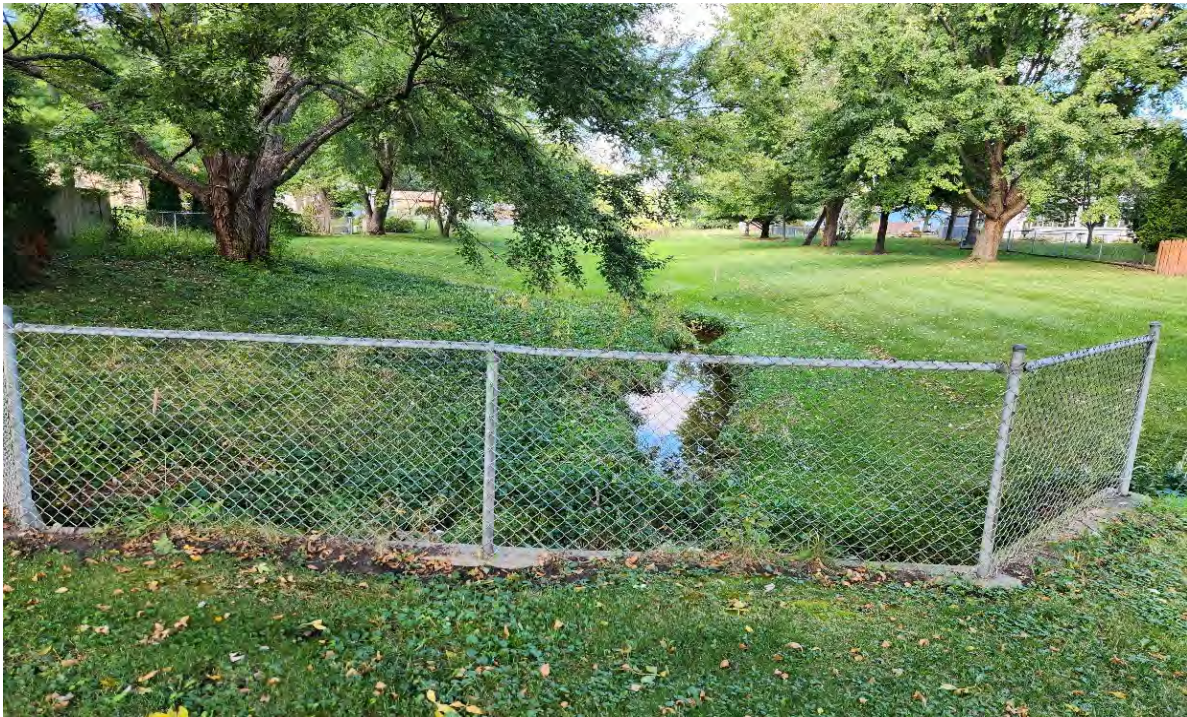
Figure 2. The grassed waterway looking upstream of Buckeye Road. This segment of channel is relatively stable, but this photo shows channel incision beginning at the downstream end of the reach (photo Inter-Fluve).

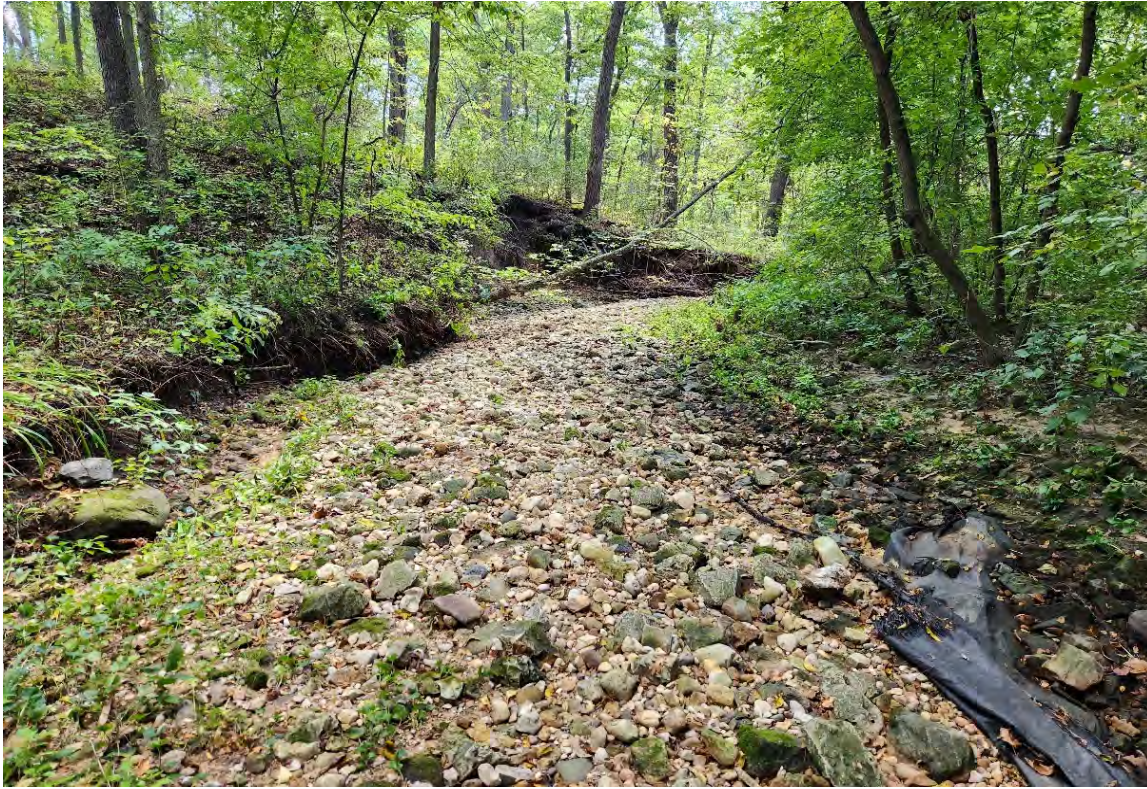
Figure 3. Bank and bluff erosion observed in the armored lower segment of Pennito Creek. Note large bar of mobile bedload and exposed underlying geotextile fabric (photo Inter-Fluve).

Downstream of Buckeye Road, a few select areas of bluff erosion or localized scour around debris jams are present, but do not represent a risk to infrastructure or a significant source of sediment to downstream reaches (Figure 2). Eroding channel material is depositing just downstream and is essentially locked up within the most immediate downstream cross-sections.
