PROJECT DESCRIPTION

AMDAHL PROPERTY
214 S. Marquette Street
Madison, WI 53704

FIELD CONDITIONS on June 20, 2011

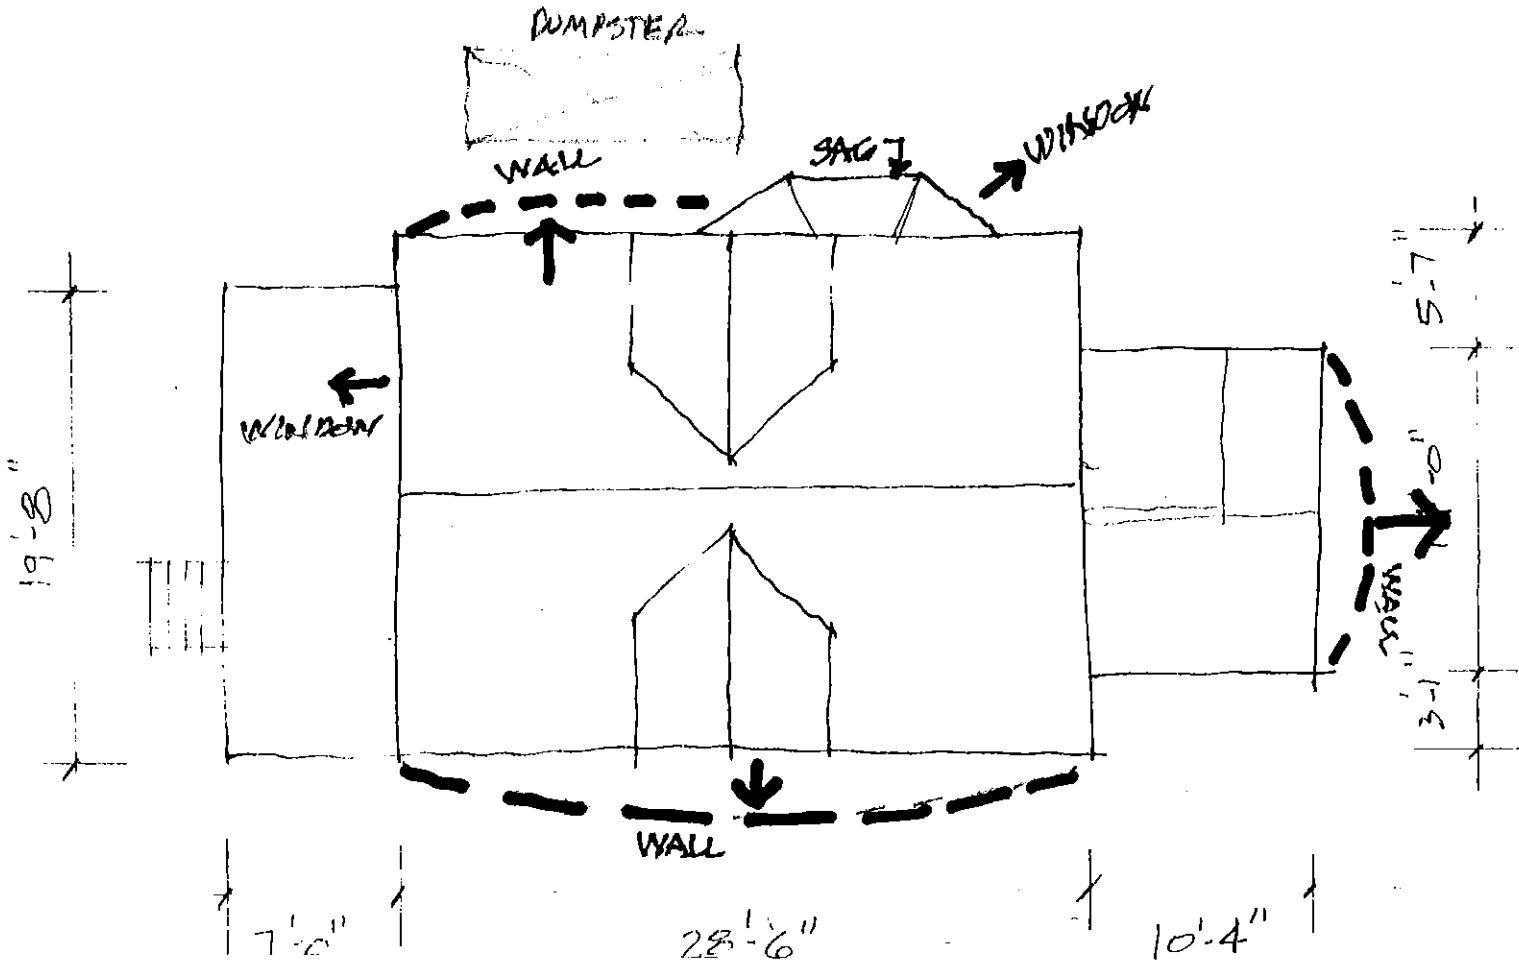
SITE PLAN

MOVEMENT OF WALLS FROM EXPLOSION

DIRECTION OF WALL MOVEMENT

- 1 Remove existing 2 unit, 2 story wood frame building damaged by explosion
- 2 Remove basement and backfill with clean fill, spread topsoil 4" and seed/mulch.
- 3 Remove wood frame garage and sidewalks at front and side of house
