SUMMARY OF STAFF RECOMMENDATIONS TO TRANSPORTATION COMMISSION

March 19, 2025

2024 TRAFFIC SIGNAL PRIORITY LIST SPECIAL STUDIES FOR TRANSPORTATION COMMISSION SELECT INTERSECTIONS

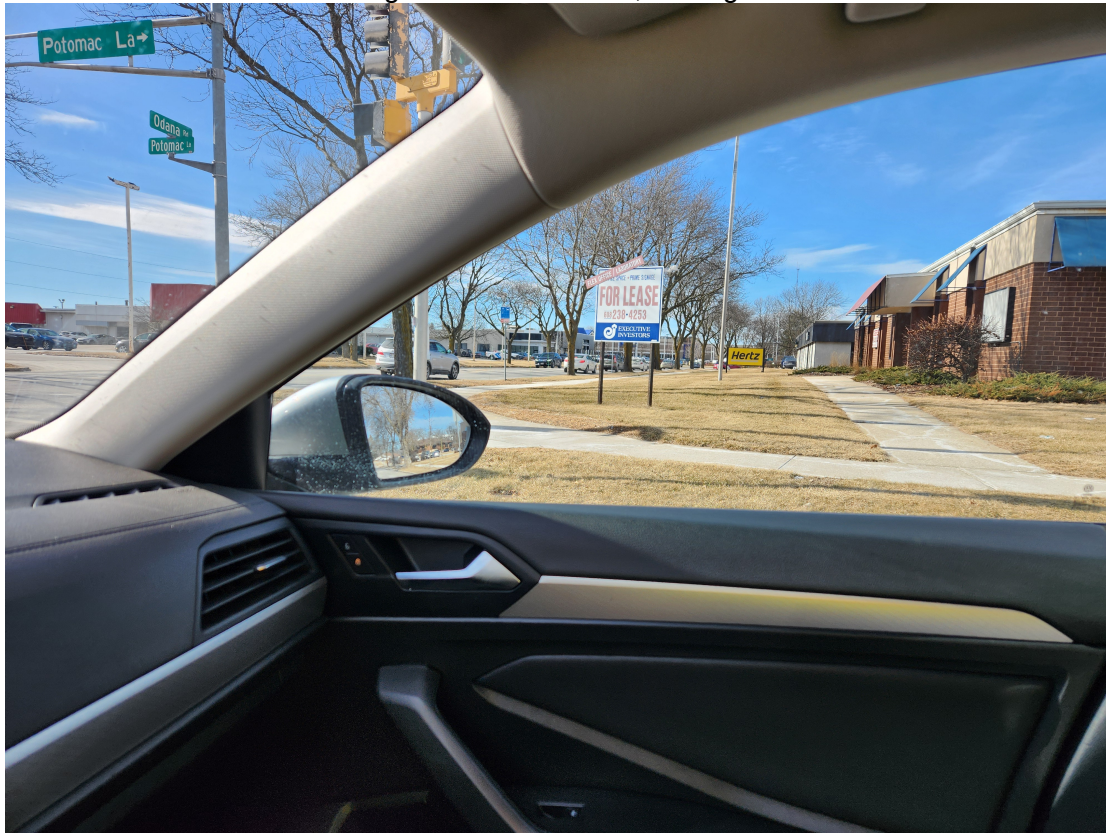
Figure 2: SB Potomac, looking west

- An automated hose count indicates this intersection does not currently meet traffic signal warrants 1-A, 1-B, or peak hour warrants.
 - Current redevelopment on the south side of the intersection is expected to bring this intersection closer to meeting traffic signal warrant.
- The signal spacing between this intersection and adjacent intersections is near equal distance between Research Park Boulevard and Grand Canyon Drive. This location may allow for platoon management when running in coordination.
- Visibility coming from the south side of the intersection is currently roughly 350 feet to the east, and approximately 250 feet to the west. At the posted speed limit, this is approximately 7-9 seconds down the road. At the 85th percentile speed measured, this approximately 5-7 seconds down the road. See figures 1 and 2 below.
