## Lake View Elementary Safe Routes to School Plan (March 2026)

## Priority Recommendations at Lake View Elementary

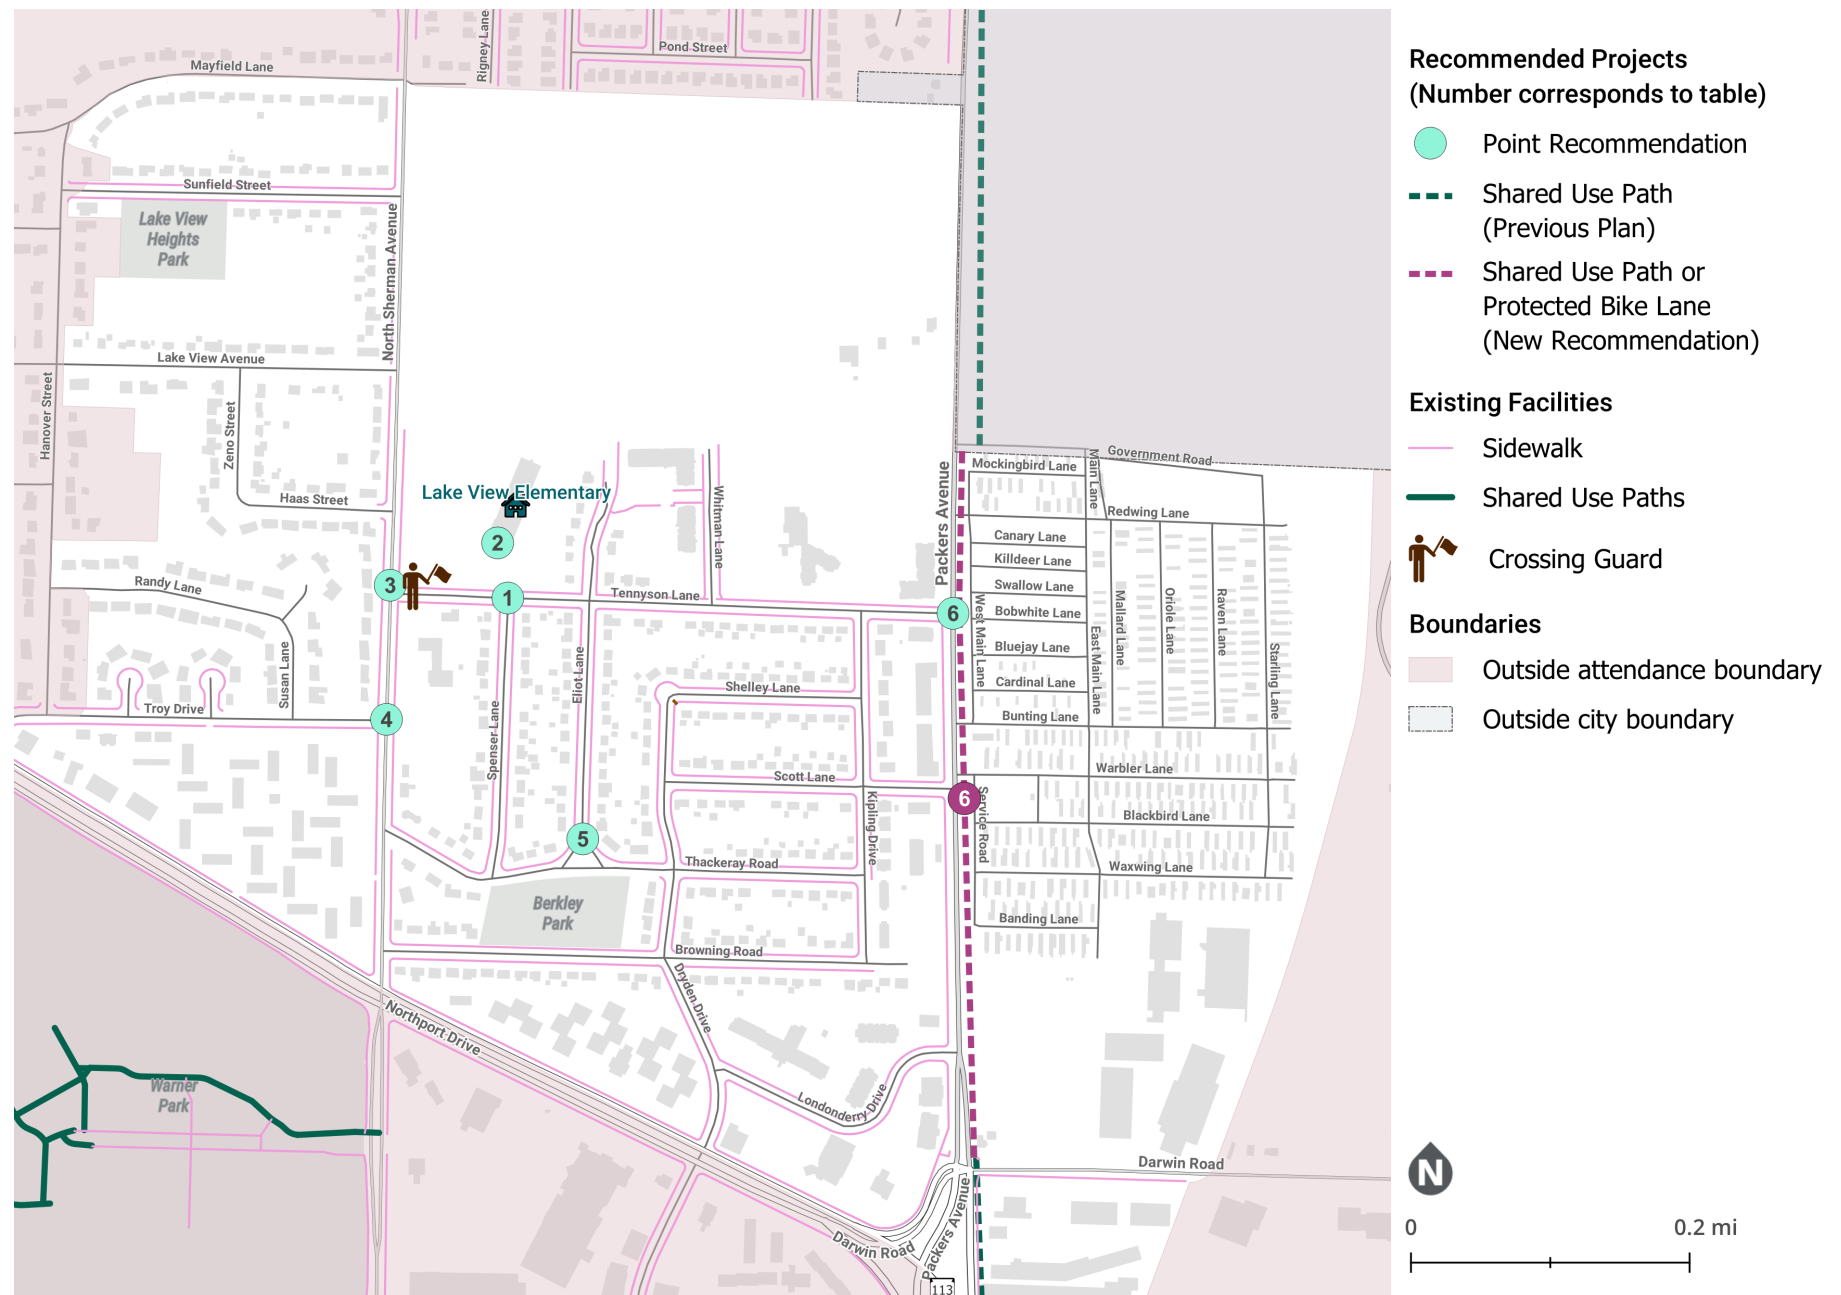
The numbered issues and recommendations in the table correspond to the points in the Recommendations Map (shown on previous page).

| # | Location | Issues or Observations | Recommendations |
|---|---|---|---|
| 1 | Spenser Lane and Tennyson Lane | <ul style="list-style-type: none"> <li>Despite No Stopping Standing Parking signs on Spenser Lane near the intersection with Tennyson, caregivers stop too close to the intersection, which limits visibility for and of pedestrians.</li> <li>Existing single curb ramps at corners do not orient users directly into the crosswalk, and the detectable warning surfaces are not contrasting colors.</li> </ul> | <i>Immediate Priority:</i> <ul style="list-style-type: none"> <li>Communicate expectations by sharing the school's Traffic Safety Plan, which should encourage caregivers who drive not to park near the crosswalk. Consider using traffic cones to block parking near the corners.</li> </ul> |
| 2 | Tennyson Lane & Staff Parking Lot exit | <ul style="list-style-type: none"> <li>Existing bicycle racks can result in damaged bikes and can make it difficult to securely lock a variety of different types of bicycles.</li> </ul> | <i>Immediate Priority:</i> <ul style="list-style-type: none"> <li>Replace the existing bike racks with new racks that support the bike frame in at least two places and that enable secure locking.</li> </ul> |
| 5 | Thackeray Road & Eliot Lane | <ul style="list-style-type: none"> <li>The Walking School Bus crosses Eliot Lane on the north side of this intersection.</li> <li>Many students cross the street at this intersection and drivers do not always yield to pedestrians in the crosswalk.</li> </ul> | <i>Immediate Priority:</i> <ul style="list-style-type: none"> <li>In high volume situations, Walking School Bus supervisors should walk students north on the east side of Eliot Lane to avoid this crossing.</li> </ul> |

| # | Location | Issues or Observations | Recommendations |
|---|---|---|---|
| 1 | Spenser Lane and Tennyson Lane | <ul style="list-style-type: none"> <li>Despite No Stopping Standing Parking signs on Spenser Lane near the intersection with Tennyson, caregivers stop too close to the intersection, which limits visibility for and of pedestrians.</li> <li>Existing single curb ramps at corners do not orient users directly into the crosswalk, and the detectable warning surfaces are not contrasting colors.</li> </ul> | <p><i>Medium Term:</i></p> <ul style="list-style-type: none"> <li>Assess curb ramp for improved alignment (southwest heading southeast), and reconstruct or update curb ramp, as necessary.</li> <li>Add curb extensions on the south leg to discourage caregivers from stopping and improve pedestrian visibility and safety.</li> </ul> |
| 3 | Tennyson Lane & N Sherman Avenue | <ul style="list-style-type: none"> <li>A crossing guard is posted at this intersection, primarily crossing students on the north leg of the intersection.</li> <li>Many students cross the street at this intersection, and drivers do not always yield to pedestrians in the crosswalk when driving straight along N Sherman Avenue or turning onto N Sherman Avenue from Tennyson Lane.</li> <li>There is a lack of school zone signage approaching this crosswalk in the southbound direction. The existing northbound school crossing sign on the east side of the crosswalk across Sherman Avenue at Tennyson Lane is blocked by a wooden telephone pole.</li> <li>Sherman Avenue has a speed limit of 30 miles per hour; the school zone speed is 20 miles per hour.</li> <li>Existing single curb ramps at corners do not orient users directly into the crosswalk.</li> </ul> | <p><i>Immediate Priority:</i></p> <ul style="list-style-type: none"> <li>Relocate the northbound school crossing assembly to in front of the wooden telephone pole or on the wood pole on the northeast corner. The southbound school crossing assembly on the east side of Sherman Avenue can remain or be relocated to the wood pole.</li> <li>Consider lowering school zone speed limits to 15 miles per hour on Sherman Avenue.</li> <li>Install SCHOOL SPEED LIMIT (R2-1) sign on the southbound approach to the intersection, and END SCHOOL ZONE at the end of the school zone in the northbound direction.</li> </ul> <p><i>Medium Term (2-6 years):</i></p> <ul style="list-style-type: none"> <li>If warranted, add a Rectangular Rapid Flashing Beacon to further improve the safety of the crossing.</li> <li>Install curb extensions and in-lane bus stops with updated curb ramps to shorten pedestrian crossings, slow speeds, and improve visibility and alignment (northeast corner of intersection across N Sherman Avenue), and reconstruct or update curb ramp, as necessary.</li> </ul> |
| 4 | N Sherman Avenue & Troy Drive | <ul style="list-style-type: none"> <li>Existing single curb ramps at corners do not orient users directly into the crosswalk.</li> <li>N Sherman Avenue is on the City's High Injury Network. Residents report vehicles go too fast for conditions.</li> </ul> | <p><i>Medium Term:</i></p> <ul style="list-style-type: none"> <li>Install curb extensions on the northwest and southwest corners of the intersection with updated curb ramps to shorten pedestrian crossings and slow speeds.</li> </ul> |

| # | Location | Issues or Observations | Recommendations |
|---|---|---|---|
| 5 | Thackeray Road & Eliot Lane | <ul style="list-style-type: none"> <li>The Walking School Bus crosses Eliot Lane on the north side of this intersection.</li> <li>Many students cross the street at this intersection, and drivers do not always yield to pedestrians in the crosswalk.</li> </ul> | <p><i>Immediate Priority:</i></p> <ul style="list-style-type: none"> <li>Add high visibility crosswalk markings.</li> </ul> <p><i>Long Term (6+ years):</i></p> <ul style="list-style-type: none"> <li>Remove west leg of Eliot Lane at Thackeray Road completely, modify existing east leg as needed to accommodate turning vehicles, and reconstruct sidewalks to follow the new curb lines. Relocate pedestrian crossing adjacent to the north side of Thackeray Road.</li> </ul> |
| 6 | Tennyson Lane & Packers Avenue | <ul style="list-style-type: none"> <li>The neighborhood east of Tennyson Lane does have access to busing but some older students walk because the school is close.</li> <li>Middle and high school students also use this crosswalk to get to and from their bus stops.</li> <li>Existing single curb ramps at corners do not orient users directly into the crosswalk.</li> <li>Curb ramp does not appear to be ADA compliant.</li> <li>Packers Avenue lacks a sidewalk on the east side of the street; there is no paved connection between the waiting pad on the east end of the crosswalk the Oak Park Terrace mobile home neighborhood to the east.</li> </ul> | <p><i>Medium Term (2-6 years):</i></p> <ul style="list-style-type: none"> <li>Construct a pedestrian refuge median on the north leg to shorten crossing distances and improve pedestrian safety.</li> <li>Assess curb ramp on the northwest corner of the intersection for improved alignment with a reduced corner radius, and reconstruct or update curb ramp, as necessary.</li> <li>Build a connector sidewalk or install the recommended sidepath on the east side of Sherman Avenue.</li> </ul> |
