# Orchard Ridge Elementary Safe Routes to School Plan (June 2026)

## Safety Concerns at Orchard Ridge

# Priority Recommendations at Orchard Ridge Elementary

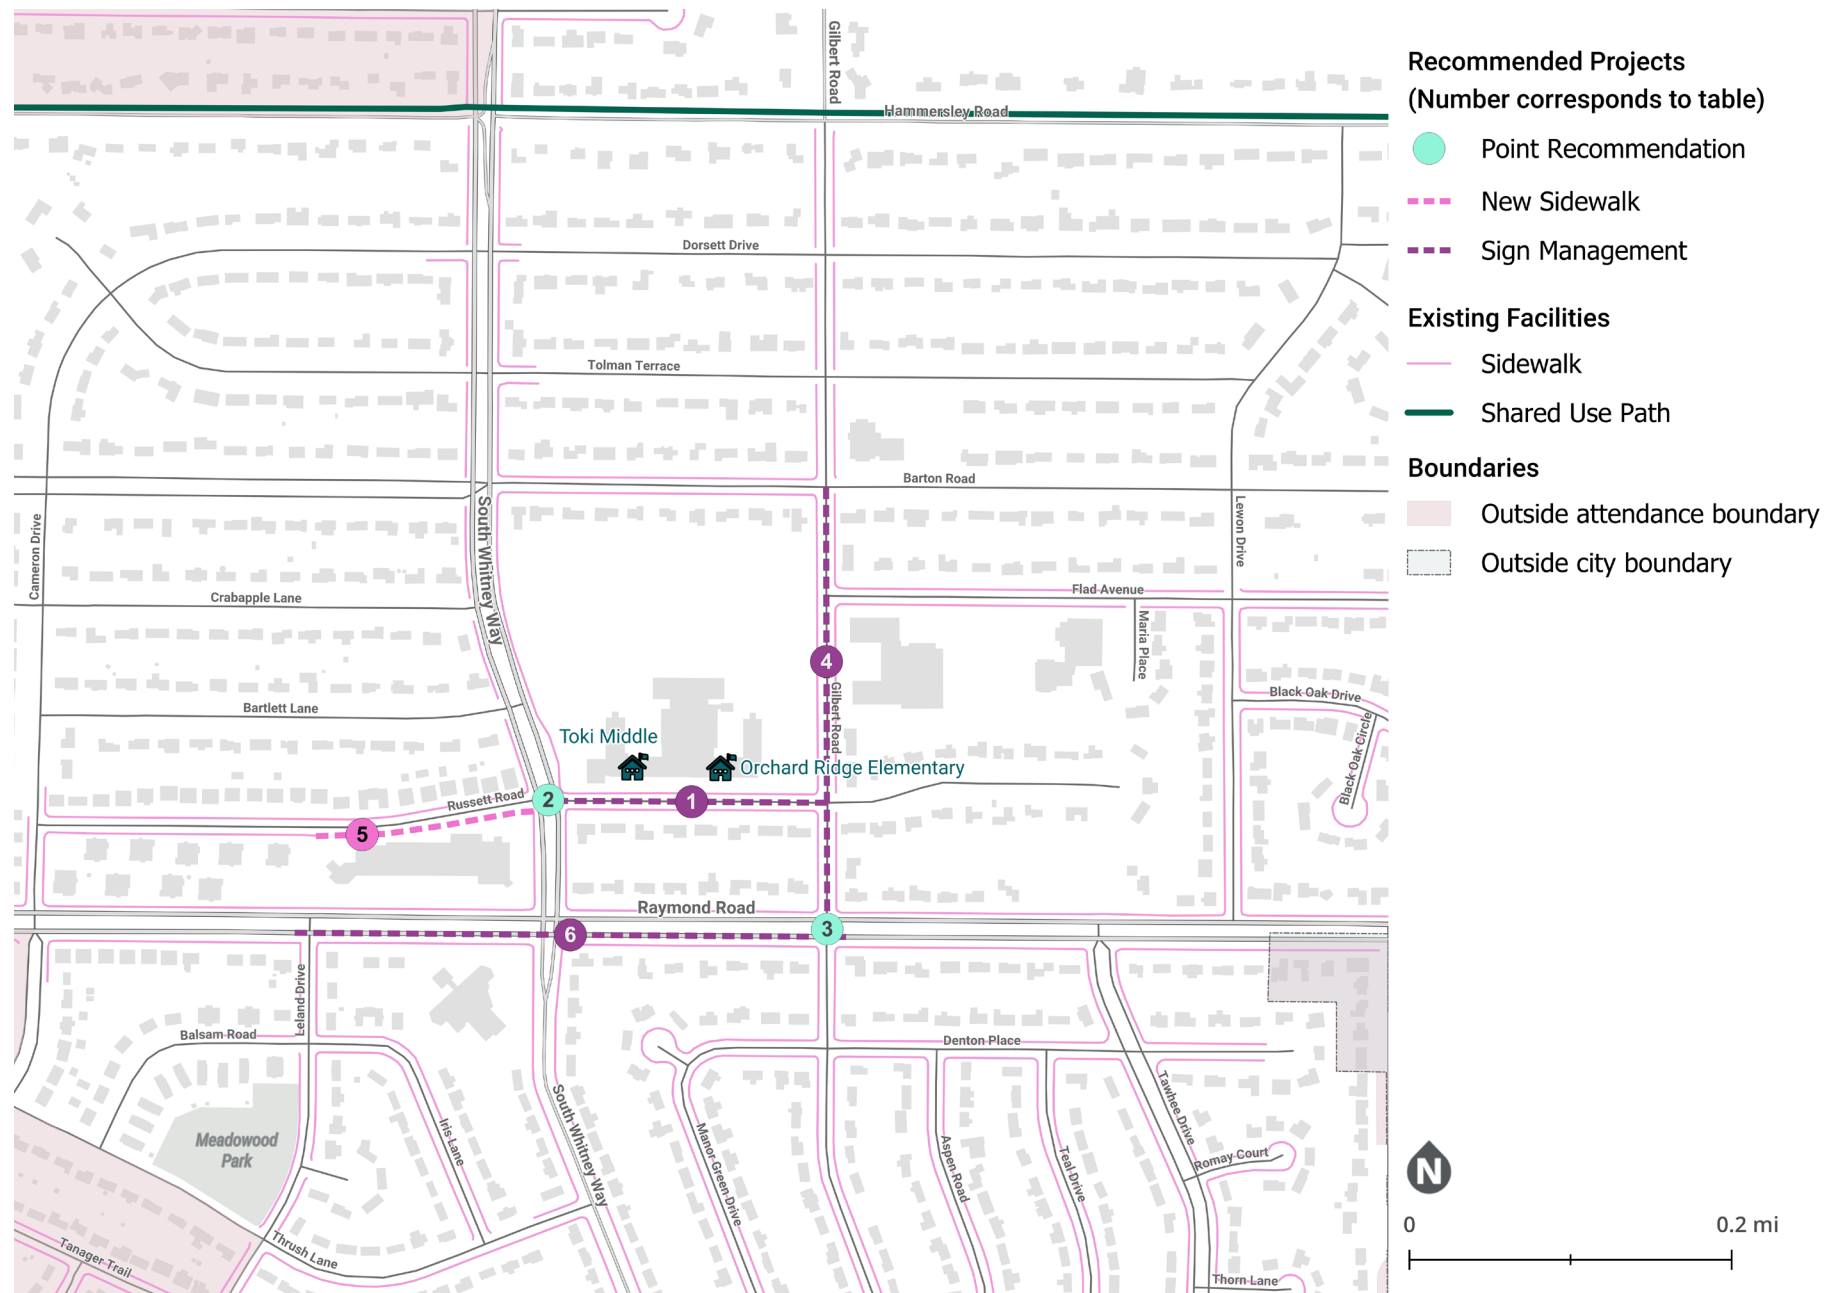
The numbered issues and recommendations in the table correspond to the points in the Recommendations Map (shown on previous page).

| # | Location | Issue | Recommendations |
|---|---|---|---|
| 1 | Along Russett Rd from Whitney Way to Gilbert Rd | <ul style="list-style-type: none"><li>• This street carries the most caregiver vehicle traffic and gets congested during arrival and dismissal. The congestion itself is not a safety concern, but it does limit visibility for people crossing the street.</li><li>• Caregivers and students were observed crossing between the yellow school buses to reach vehicles parked on the other side of the street.</li><li>• High density of signs along Russett Rd may lead to inconsistencies in parking restrictions and confusion for caregivers who drive.</li><li>• Caregivers were observed stopping, standing, or parking along areas where this is prohibited.</li></ul> | <p><i>Immediate Priority:</i></p> <ul style="list-style-type: none"><li>• Communicate expectations by sharing the school's Transportation Safety Brochure, which should encourage caregivers who drive to park along the north side of Russett Rd.</li></ul> |

| # | Location | Issue | Recommendations |
|---|---|---|---|
| 1 | Along Russett Rd from Whitney Way to Gilbert Rd | <ul style="list-style-type: none"> <li>This street carries the most caregiver vehicle traffic and gets congested during arrival and dismissal. The congestion itself is not a safety concern, but it does limit visibility for people crossing the street.</li> <li>Caregivers and students were observed crossing between the yellow school buses to reach vehicles parked on the other side of the street.</li> <li>High density of signs along Russett Rd may lead to inconsistencies in parking restrictions and confusion for caregivers who drive.</li> <li>Caregivers were observed stopping, standing, or parking along areas where this is prohibited.</li> </ul> | <p><i>Immediate Priority:</i></p> <ul style="list-style-type: none"> <li>Survey existing signage along Russett Rd to ensure consistency. If possible, reduce the density of signs along the street to avoid confusion for caregivers who drive.</li> <li>Consider painting curbs yellow to further communicate no parking locations.</li> </ul> |
| 2 | Whitney Way at Russett Rd | <ul style="list-style-type: none"> <li>The existing crossing (where a crossing guard is posted) lacks high visibility crosswalk markings on the west and east legs of the intersection</li> <li>Existing single curb ramps at corners do not orient users directly into the crosswalk.</li> </ul> | <p><i>Immediate Priority:</i></p> <ul style="list-style-type: none"> <li>Add high visibility crosswalk markings to the west and east legs of the intersection.</li> </ul> <p><i>Long Term (6+ years):</i></p> <ul style="list-style-type: none"> <li>Install new curb ramps that line up with crosswalks on all legs of the intersection.</li> </ul> |
| 3 | Gilbert Rd at Raymond Rd | <ul style="list-style-type: none"> <li>The existing crossing (where a crossing guard is posted) lacks high visibility crosswalk markings because of road patching work that occurred where the crosswalk is located.</li> <li>Existing single curb ramps connecting to the south, north, and east legs of the intersection do not orient users directly into the crosswalk.</li> </ul> | <p><i>Immediate Priority:</i></p> <ul style="list-style-type: none"> <li>Re-do high visibility crosswalk markings on all legs of the intersection.</li> </ul> <p><i>Medium Term (2-6 years)</i></p> <ul style="list-style-type: none"> <li>Extend the existing median to provide a raised pedestrian refuge for pedestrians.</li> </ul> <p><i>Long Term (6+ years):</i></p> <ul style="list-style-type: none"> <li>Install new curb ramps that line up with crosswalks on all legs of the intersection.</li> </ul> |
| 4 | Along Gilbert Rd from Barton Rd to Raymond Rd | <ul style="list-style-type: none"> <li>High density of signs along Gilbert Rd may lead to inconsistencies in parking restrictions and confusion for caregivers who drive.</li> </ul> | <p><i>Immediate Priority:</i></p> <ul style="list-style-type: none"> <li>Survey existing signage along Gilbert Rd to ensure consistency. If possible, reduce the density of signs along the street to avoid confusion for caregivers who drive.</li> </ul> |

| # | Location | Issue | Recommendations |
|---|---|---|---|
| 5 | Russett Rd (along the north side of Meadowood Center and First National Bank) | <ul style="list-style-type: none"><li>• This is the route of an existing walking school bus that starts by the First National Bank.</li><li>• The location is nearby the school, and there are currently no sidewalks along this section on the south side of Russett Rd, which can make walking to school unsafe.</li></ul> | <p><i>Medium Term (2-6 years))</i></p> <ul style="list-style-type: none"><li>• Install a midblock crossing near the end of the existing sidewalk on the south side of Russet Rd so students can cross to the north side of Russet Rd.</li></ul> <p><i>Long Term (6+ years)</i></p> <ul style="list-style-type: none"><li>• As part of a redevelopment project, require property owner to construct sidewalks along the south side of this section, connecting to the crosswalk at Russett Rd and Whitney Way.</li></ul> |
| 6 | Raymond Rd (east of Leland Dr to west of Gilbert Rd) | <ul style="list-style-type: none"><li>• Inconsistencies amongst School Speed Zones signs placed along this corridor.</li></ul> | <p><i>Immediate Priority:</i></p> <ul style="list-style-type: none"><li>• Extend the reduced speed school zone so that it includes the intersection of Raymond Rd and Laland Dr, and the intersection of Raymond Rd and Gilbert Rd.</li></ul> |
