## Sandburg Elementary Safe Routes to School Plan (June 2026)

## Priority Recommendations at Sandburg Elementary

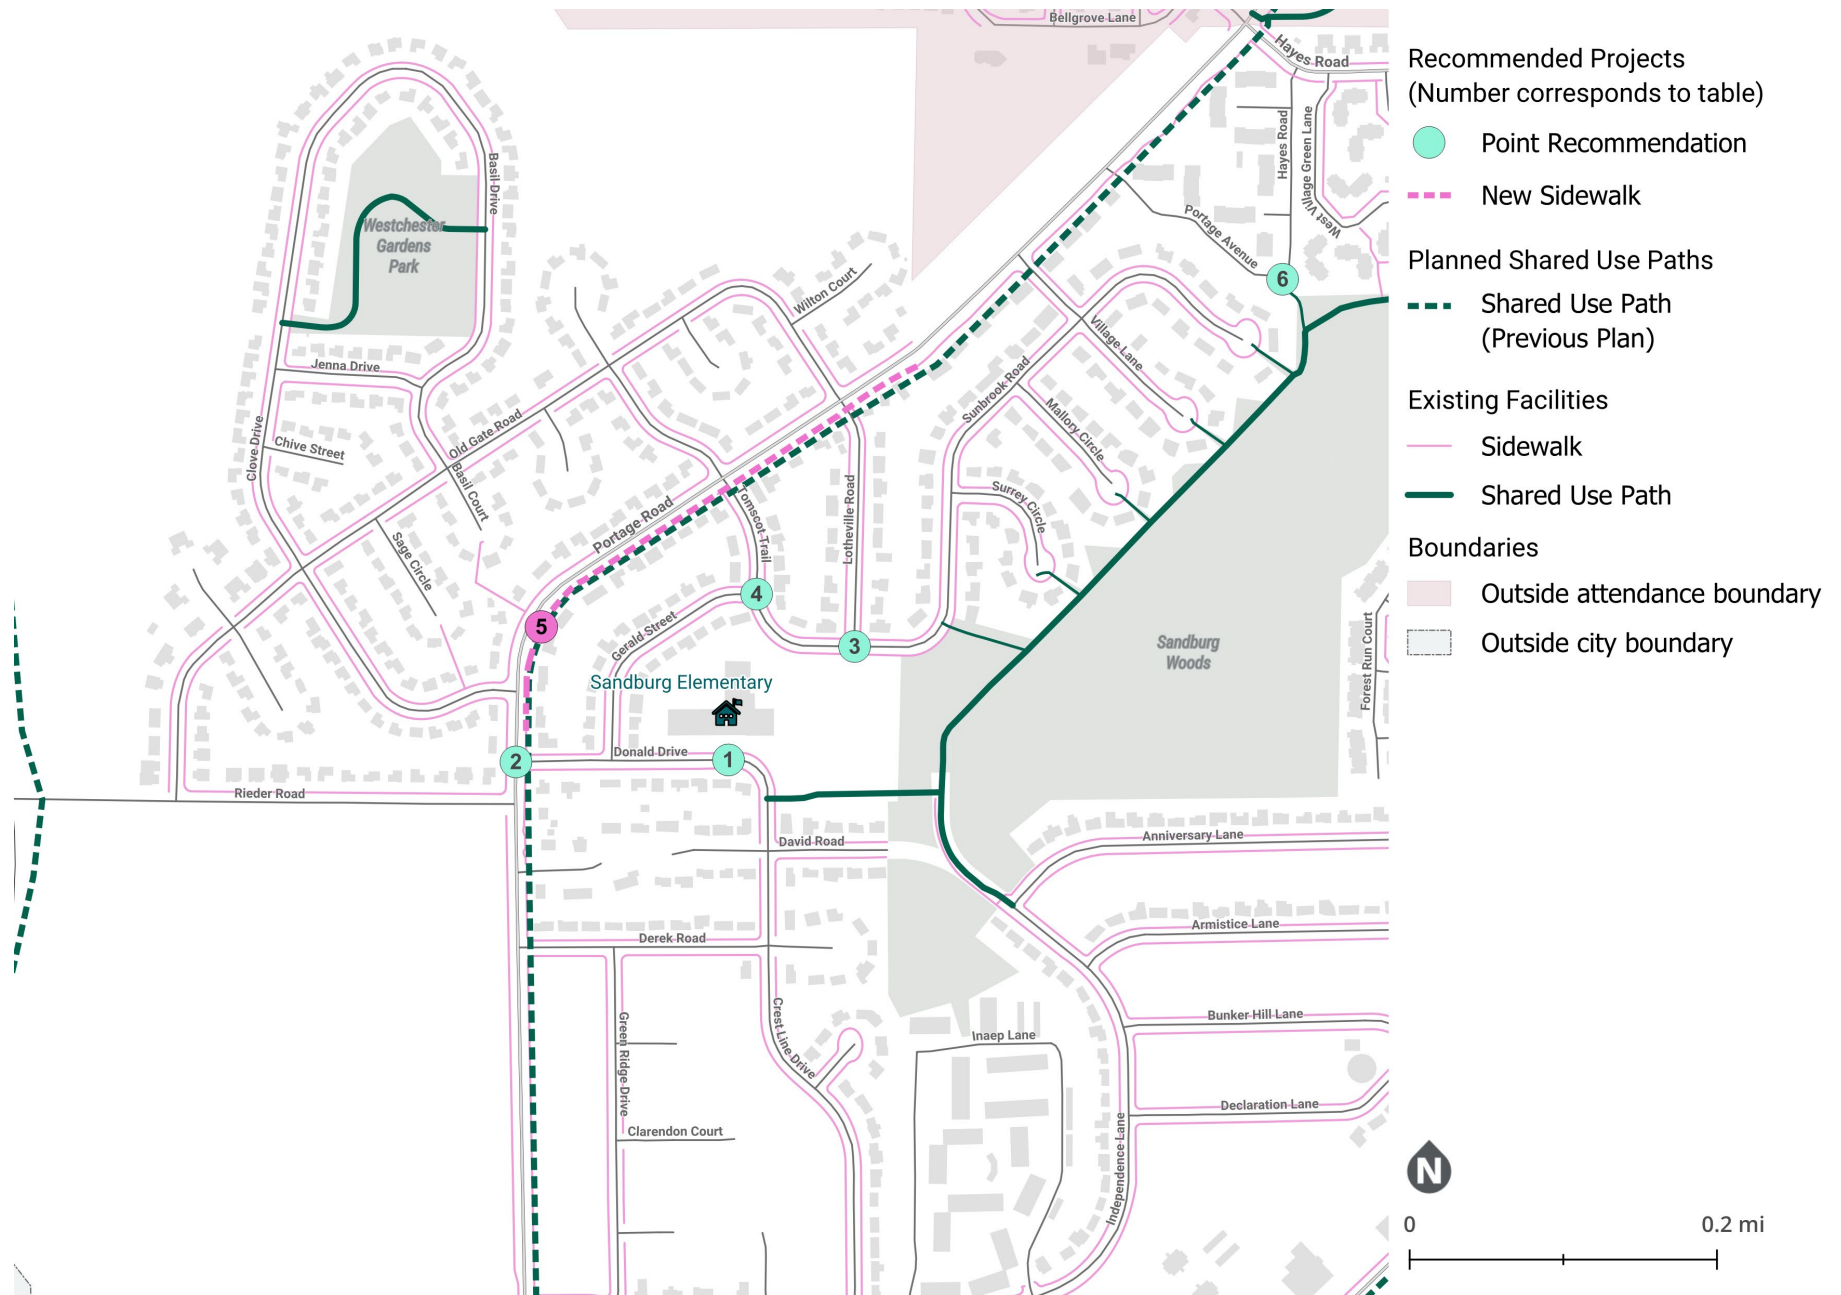
The numbered issues and recommendations in the table correspond to the points in the Recommendations Map (shown on previous page).

| # | Location | Issue | Recommendations |
|---|---|---|---|
| 1 | Donald Dr (at school entrance) | <ul style="list-style-type: none"><li>• This street carries the most caregiver vehicle traffic and gets congested during arrival and dismissal. The congestion itself is not a safety concern, but it does limit visibility for people crossing the street.</li><li>• Caregivers and students were observed crossing between the yellow school buses to reach vehicles parked on the other side of the street.</li></ul> | <p><i>Immediate Priority:</i></p> <ul style="list-style-type: none"><li>• Communicate expectations by sharing the school's Transportation Safety Brochure, which should discourage caregivers from stopping or parking on the south side of Donald Dr, and encourage caregivers to use the assigned pickup and drop off locations for their student's respective grade.</li><li>• Place sandwich boards by the bus area that say BUSES ONLY.</li></ul> |

| # | Location | Issue | Recommendations |
|---|---|---|---|
| 2 | Portage Rd at Donald Dr | <ul style="list-style-type: none"> <li>The existing crosswalk does not have high visibility markings on the east leg of the intersection.</li> </ul> | <p><i>Immediate Priority:</i></p> <ul style="list-style-type: none"> <li>Add high visibility crosswalk markings to the east legs of the intersection.</li> </ul> <p><i>Long Term (6+ years):</i></p> <ul style="list-style-type: none"> <li>Install new curb ramps that line up with crosswalks on all legs of the intersection.</li> </ul> |
| 3 | Tomscot Trail (at Lotheville Rd) | <ul style="list-style-type: none"> <li>Existing single curb ramps on the northwest and northeast corners of the intersection do not orient users directly into the crosswalk.</li> </ul> | <p><i>Immediate Priority:</i></p> <ul style="list-style-type: none"> <li>Add high visibility crosswalk markings across the Lotheville Rd leg of the intersection.</li> </ul> <p><i>Long Term (6+ years):</i></p> <ul style="list-style-type: none"> <li>Install new curb ramps that line up with crosswalks on all legs of the intersection.</li> </ul> |
| 4 | Tomscot Trail (at Gerald St) | <ul style="list-style-type: none"> <li>The existing crossing is not highly visible to drivers because many caregivers or school staff park around this crossing.</li> </ul> | <p><i>Immediate Priority:</i></p> <ul style="list-style-type: none"> <li>Add high visibility crosswalk markings to the south leg across Tomscot Trail and the west leg across Gerald St and parking restrictions on both crosswalk approaches.</li> </ul> |
| 5 | Portage Road (from south of Village Lane to north of Donald Drive) | <ul style="list-style-type: none"> <li>Missing sidewalk on the east side of the street presents barriers to walking and bicycling to school.</li> </ul> | <p><i>Medium Term (2-6 years):</i></p> <ul style="list-style-type: none"> <li>Construct sidewalk on the east side of Portage Road.</li> <li>Install ADA-compliant curb ramps connecting to existing crosswalks.</li> </ul> |
| 6 | Canopy Collective (parking lot trail access between Sunbrook Rd and Village Green Ln W) | <ul style="list-style-type: none"> <li>Access path connecting to Sandburg Woods Trail 200ft to the south is unpaved/not ADA compliant.</li> </ul> | <p><i>Long Term (6+ years):</i></p> <ul style="list-style-type: none"> <li>If redeveloped, require property owner to construct access path connecting to Sandburg Woods Trail.</li> </ul> |
