# Schenk Elementary Safe Routes to School Plan (June 2026)

# Existing Conditions (and Previously-Planned Bikeways and Paths)

# Priority Recommendations at Schenk Elementary

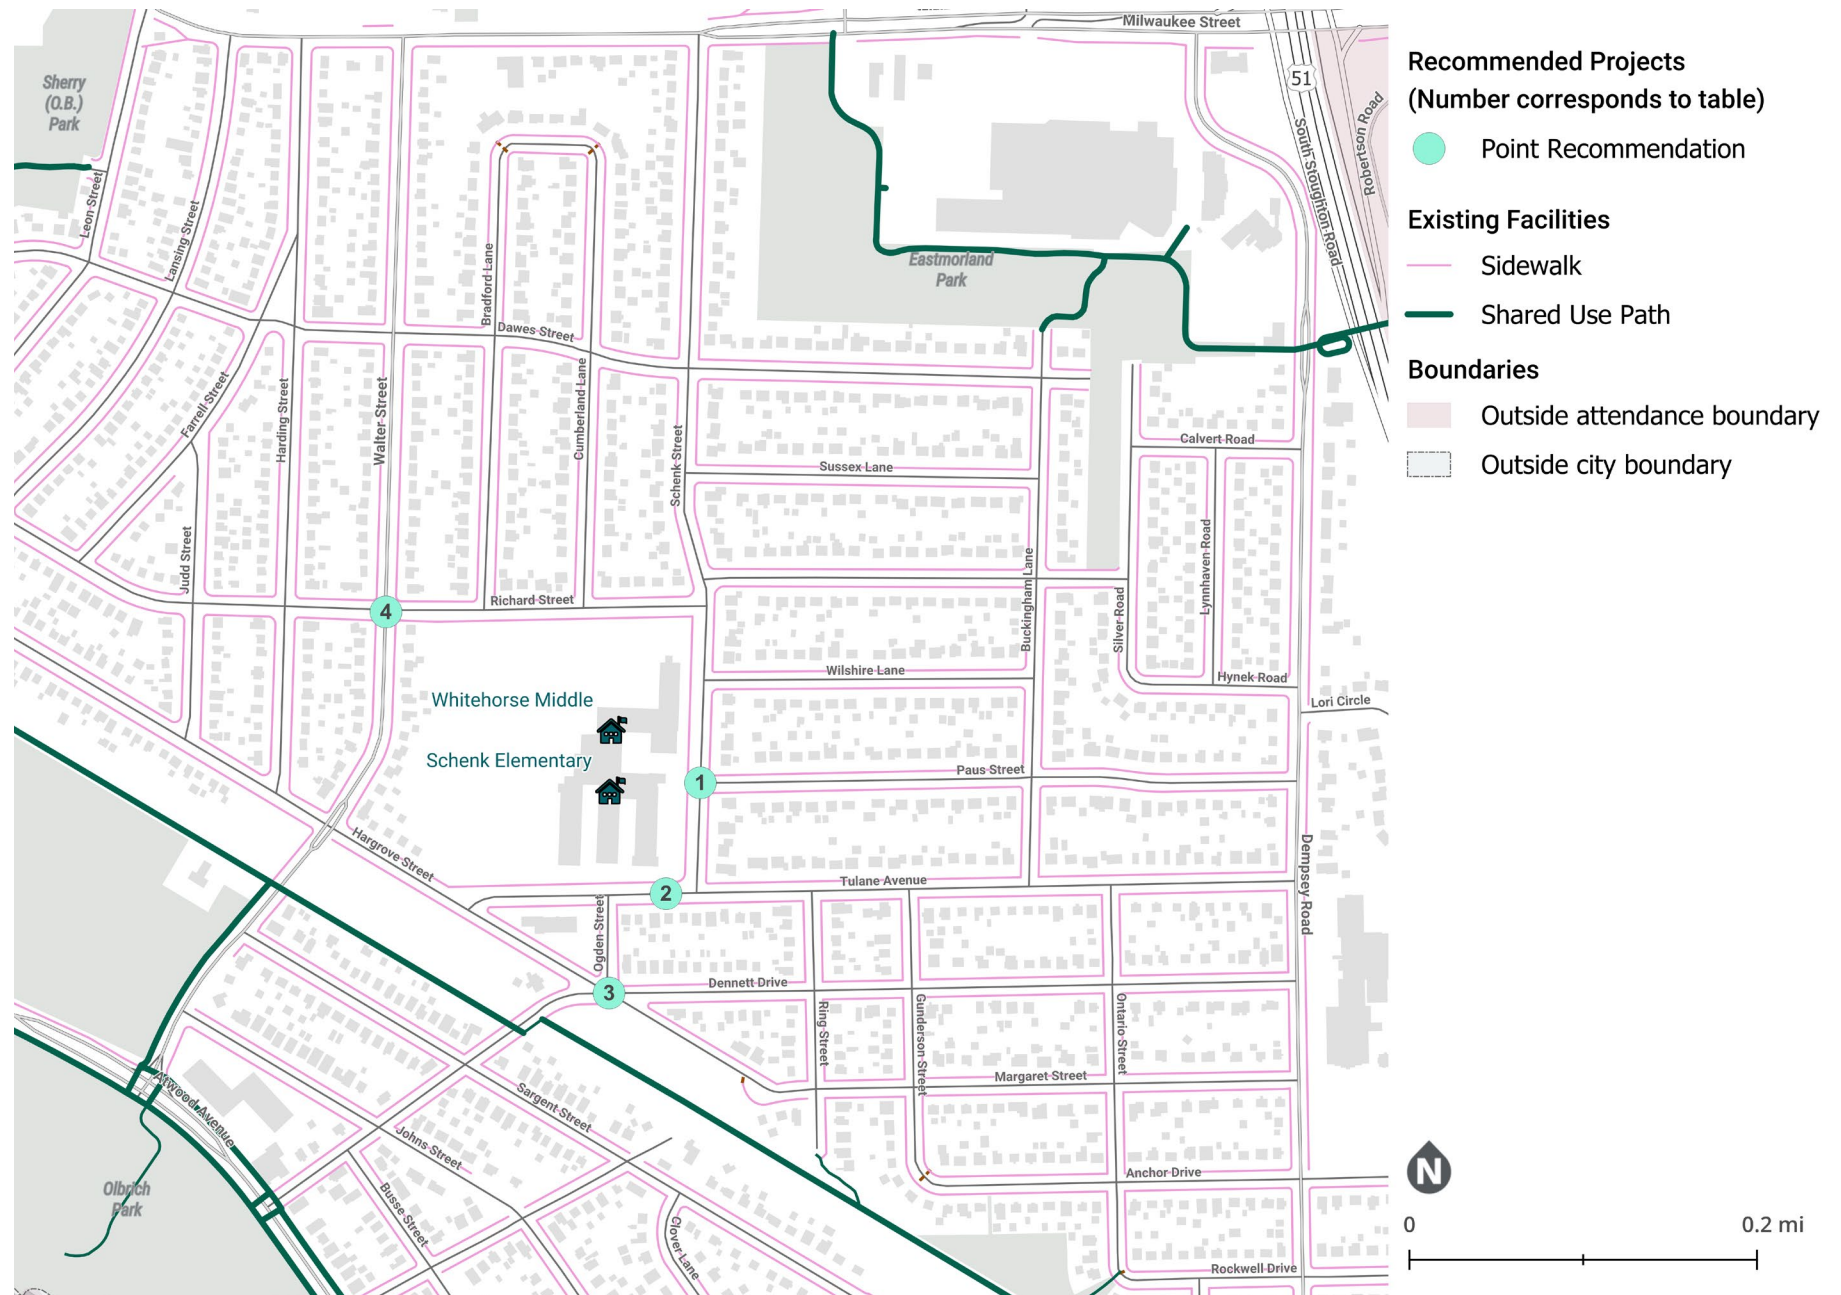
The numbered issues and recommendations in the table correspond to the points in the Recommendations Map (shown on previous page).

| # | Location | Issue | Recommendations |
|---|---|---|---|
| 1 | Schenk St at Paus St | <ul style="list-style-type: none"><li>This street carries the most caregiver vehicle traffic and gets congested during arrival and dismissal. The congestion itself is not a safety concern, but it does limit visibility for people crossing the street.</li></ul> | <i>Immediate Priority:</i> <ul style="list-style-type: none"><li>Communicate expectations by sharing the school's Transportation Safety Brochure, which should encourage caregivers who drive to use Paus St and the south side of Tulane Ave during arrival and dismissal. Encourage more walking and biking to school to reduce the number of caregiver vehicles.</li></ul> |
| 2 | Tulane Ave between Ogden St and Schenk St | <ul style="list-style-type: none"><li>Caregivers and students were observed crossing between the yellow school buses to reach caregiver vehicles on the other side of the street.</li></ul> | <i>Immediate Priority:</i> <ul style="list-style-type: none"><li>Communicate expectations by sharing the school's Transportation Safety Brochure, which should encourage caregivers who drive and students to use the marked crossing at Schenk St and Tulane Ave.</li><li>Encourage more walking and biking to school to reduce the number of caregiver vehicles.</li></ul> |

| # | Location | Issue | Recommendations |
|---|---|---|---|
| 2 | Tulane Ave between Ogden St and Schenk St | <ul style="list-style-type: none"> <li>Caregivers and students were observed crossing between the yellow school buses to reach caregiver vehicles on the other side of the street.</li> </ul> | <p><i>(The recommendation below is also included in the Whitehorse Middle SRTS Plan)</i></p> <p><i>Immediate Priority:</i></p> <ul style="list-style-type: none"> <li>Add parking restrictions on the crosswalk approach to improve sight distances.</li> </ul> |
| 3 | Hargrove St and Dennett Dr | <ul style="list-style-type: none"> <li>Residents report vehicles go too fast for conditions.</li> <li>Crossings are uncomfortable because of wide corner radii, which encourages fast vehicular turns and decreases pedestrian visibility.</li> </ul> | <p><i>Immediate Priority:</i></p> <ul style="list-style-type: none"> <li>Use FINES HIGHER (R2-6P) plaques on school speed limit assemblies.</li> </ul> <p><i>Medium Term (2-6 years)</i></p> <ul style="list-style-type: none"> <li>Tighten up the curb radii on the Hargrove St and Ogden St legs of the intersection and install new curb ramps that line up with crosswalks at all corners.</li> </ul> |
| 4 | Walter St and Richard St | <ul style="list-style-type: none"> <li>Residents report vehicles go too fast for conditions.</li> <li>Existing traffic circle does not reduce vehicle speeds adequately.</li> </ul> | <p><i>Immediate Priority:</i></p> <ul style="list-style-type: none"> <li>Add high-visibility crosswalks on all legs of the intersection.</li> </ul> <p><i>Long Term (6+ years)</i></p> <ul style="list-style-type: none"> <li>Tighten up the curb radii on all legs of the intersection and install new curb ramps that line up with crosswalks at all corners.</li> </ul> |
