Main Break Locations

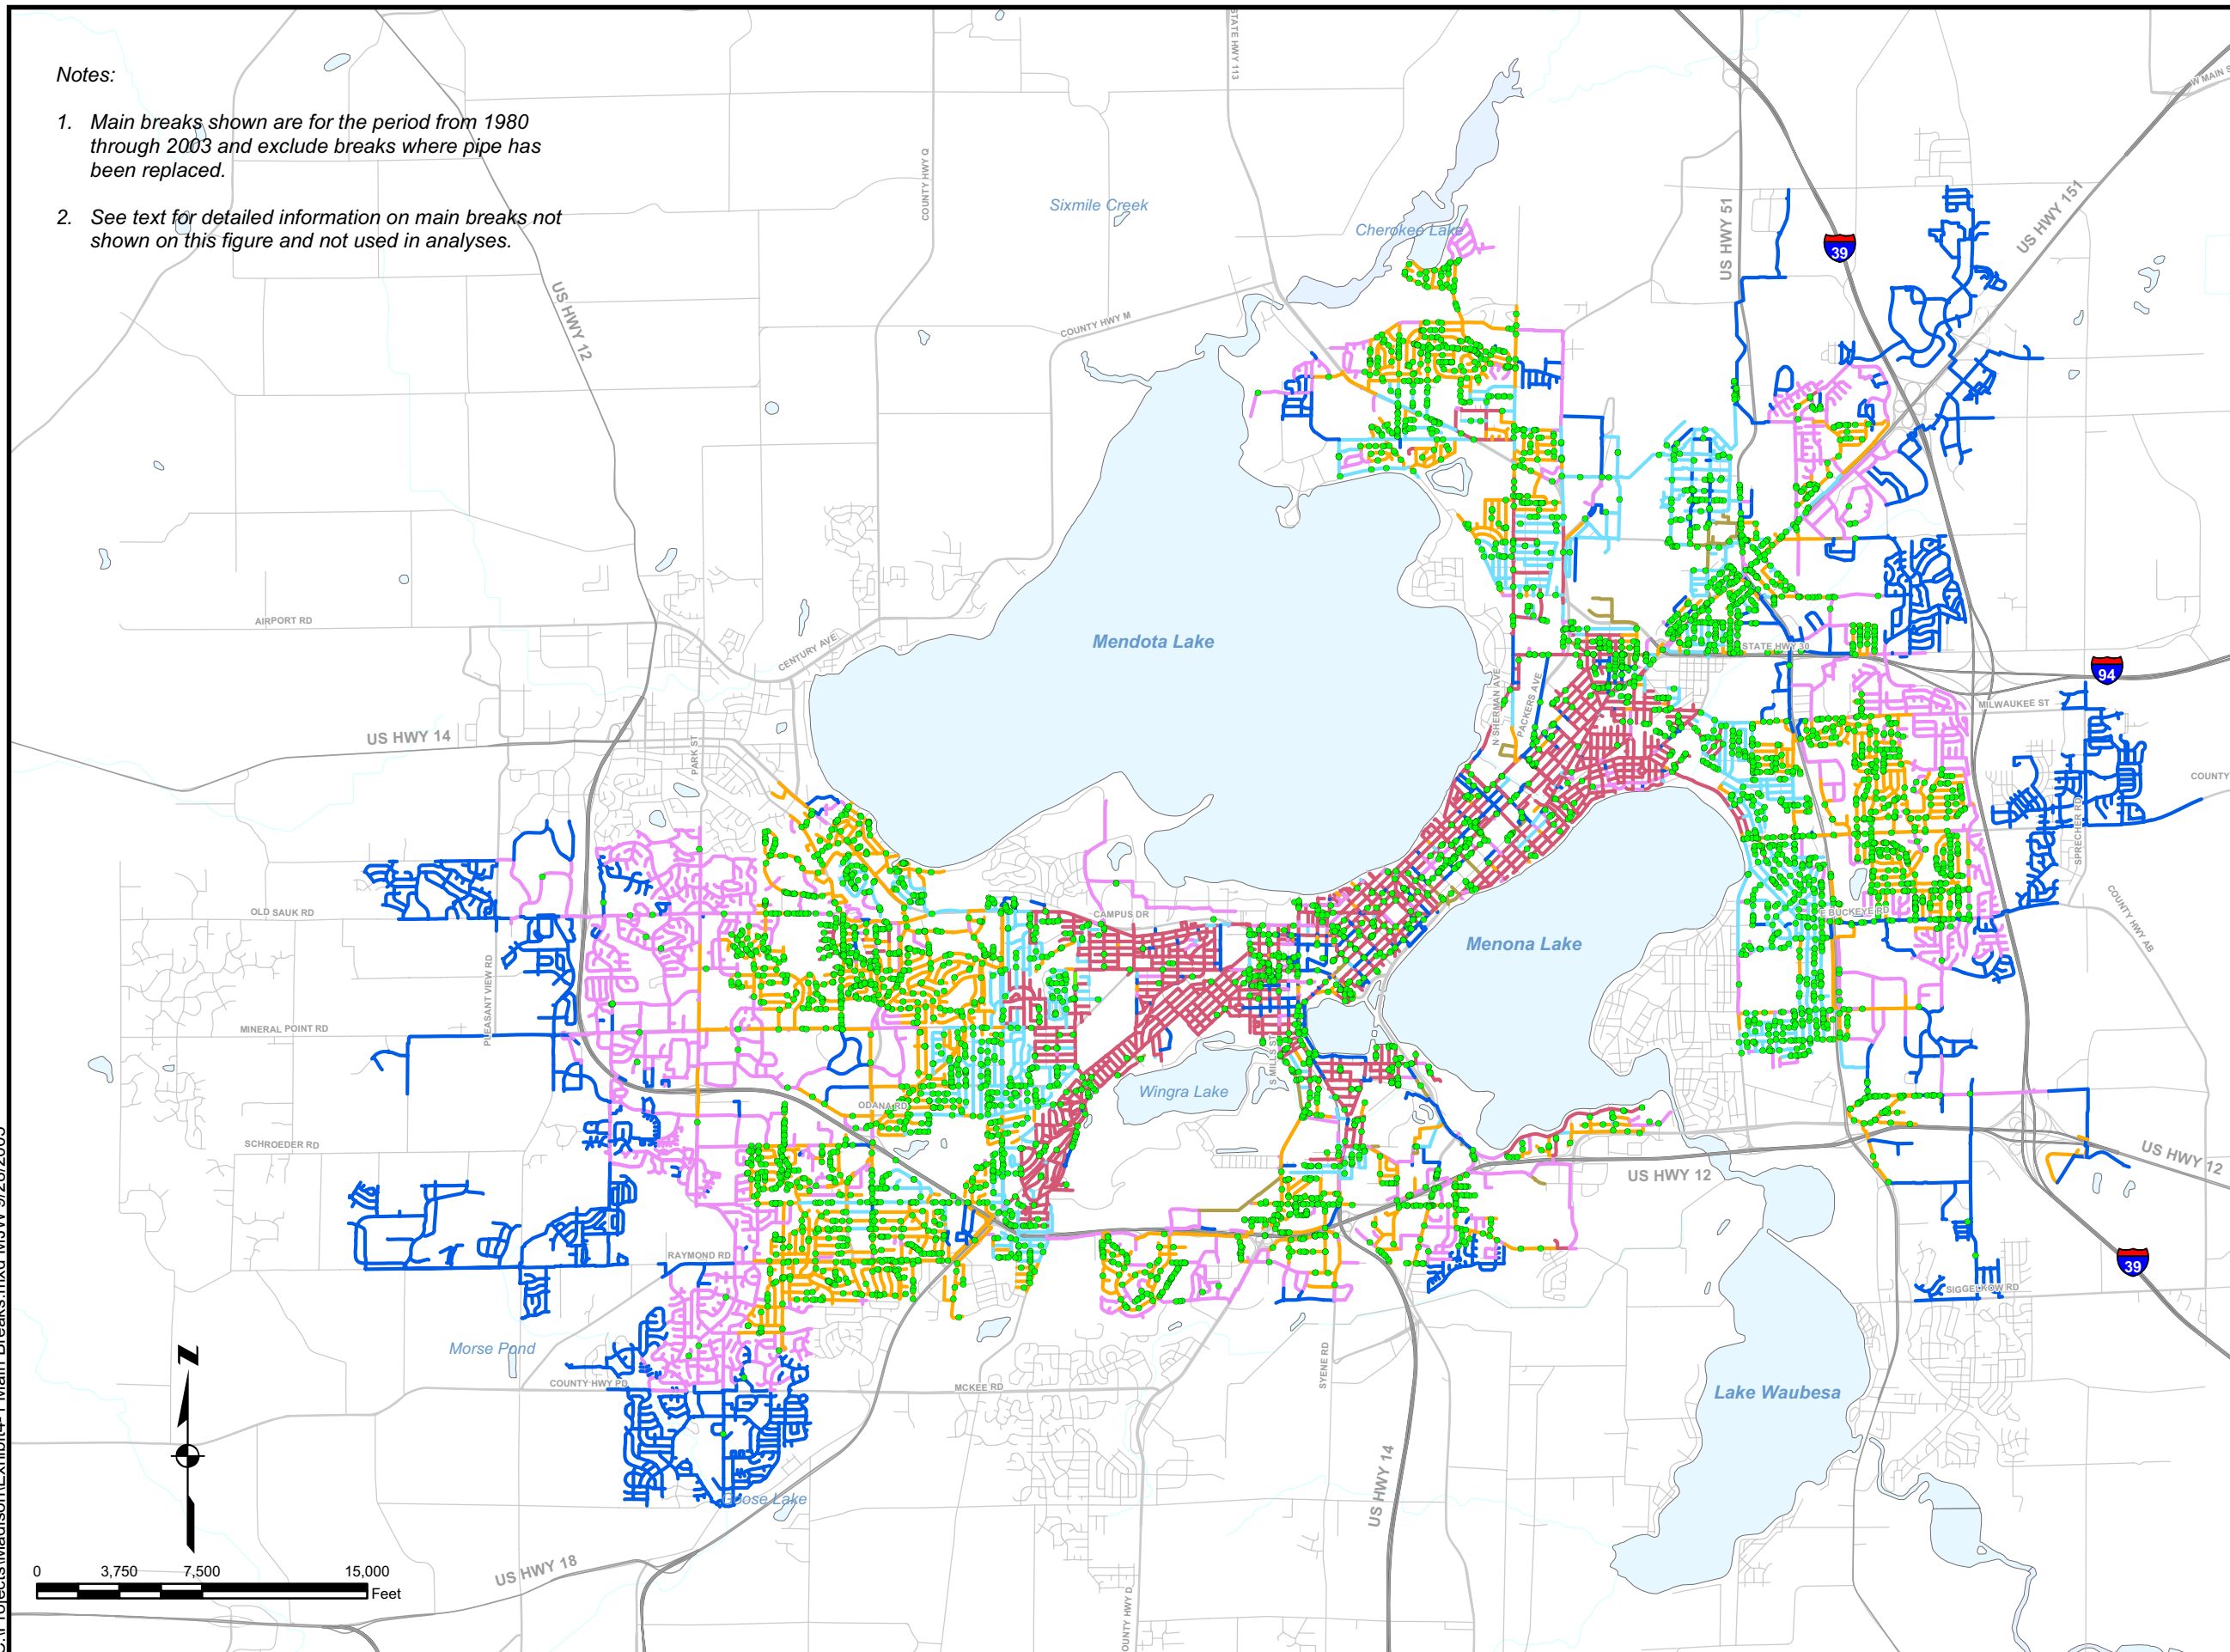
1. Main breaks shown are for the period from 1980 through 2003 and exclude breaks where pipe has been replaced.
2. See text for detailed information on main breaks not shown on this figure and not used in analyses.
